## APPLICATION PROFILE

### FRP WITHSTANDS CORROSIVE ENVIRONMENT

APPLICATION PROFILE **704**

LIFT STATION WALKING SURFACE

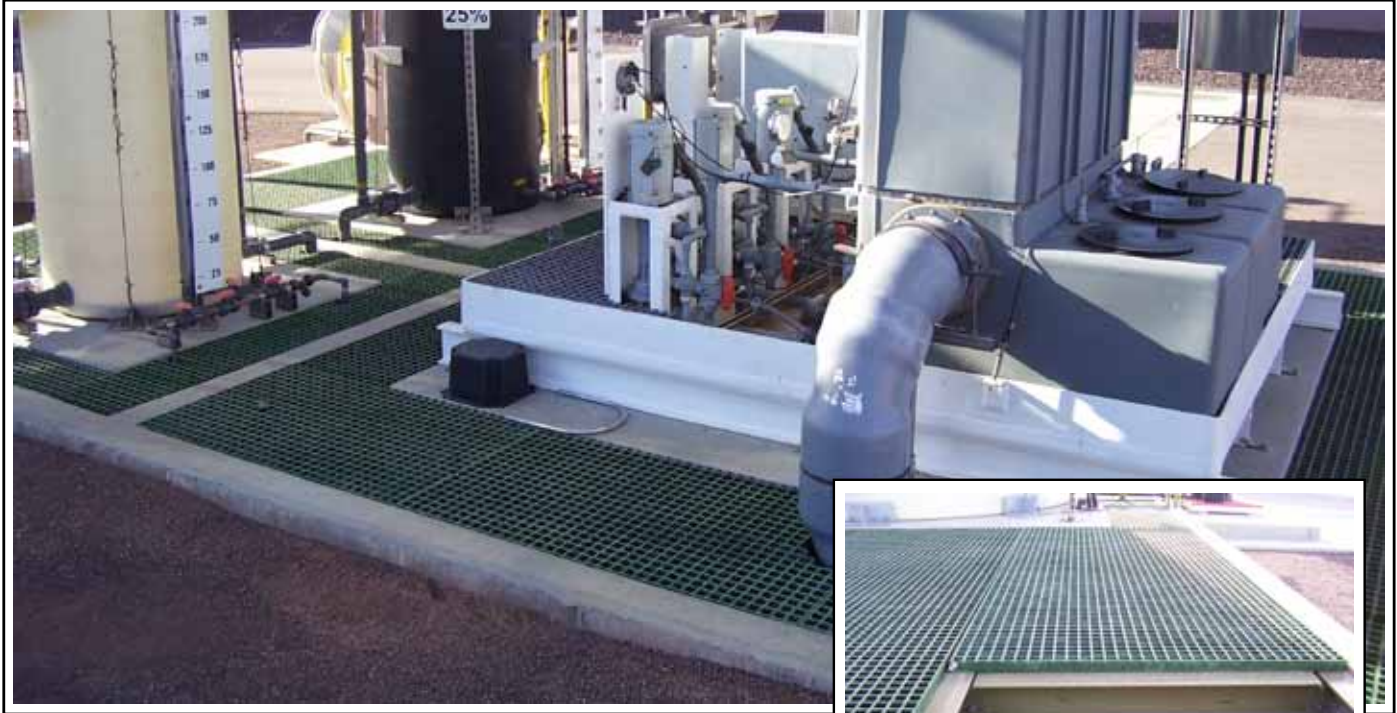
The chosen solution was sold by Molded Fiber Glass and submitted by Jacobs Engineering, whose design incorporated 1.5" DURAGRATE® molded grating. Strongwell's DURAGRATE® has high resin content (65%) that will provide the station extended maintenance-free performance and the lightweight panels are also very easy to fabricate. All walking surfaces had EXTREN® beam substructure

Additionally, non-corrosive, light weight, and strong EXTREN® fiberglass profiles were selected for subsurface structural support. The design engineer, David Holman with DE Associates, the Sr. Resident Engineer, James Shane from Jacobs Engineering Group, and the city of Phoenix were all pleased with the results and performance of the FRP products. These photos, taken in 2011, show how DURAGRATE® and EXTREN® have withstood the corrosive environment in the last two years. ●
