DoD Corrosion Prevention and Control Program

Demonstration and Validation of a Composite Grid Reinforcement System for Bridge Decks

Final Report on Project F12-AR01

September 2016

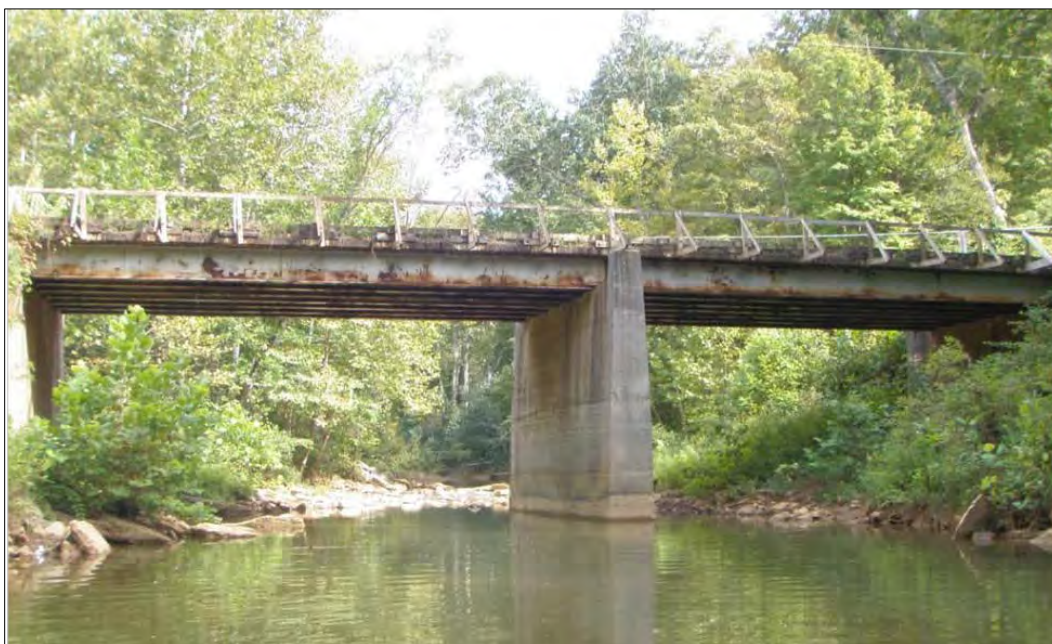
Figure 1. Bridge No. 4 at Fort Knox.

Bridge No. 4 (Figure 1) in the Fort Knox training range was one of the bridges scheduled for rehabilitation of its corroded support beams and deteriorating bridge deck. With Bridge No. 4 having two spans, it was an excellent candidate for concurrent demonstrations of a hybrid-composite beam (HCB) and the grid composite deck reinforcement technologies.

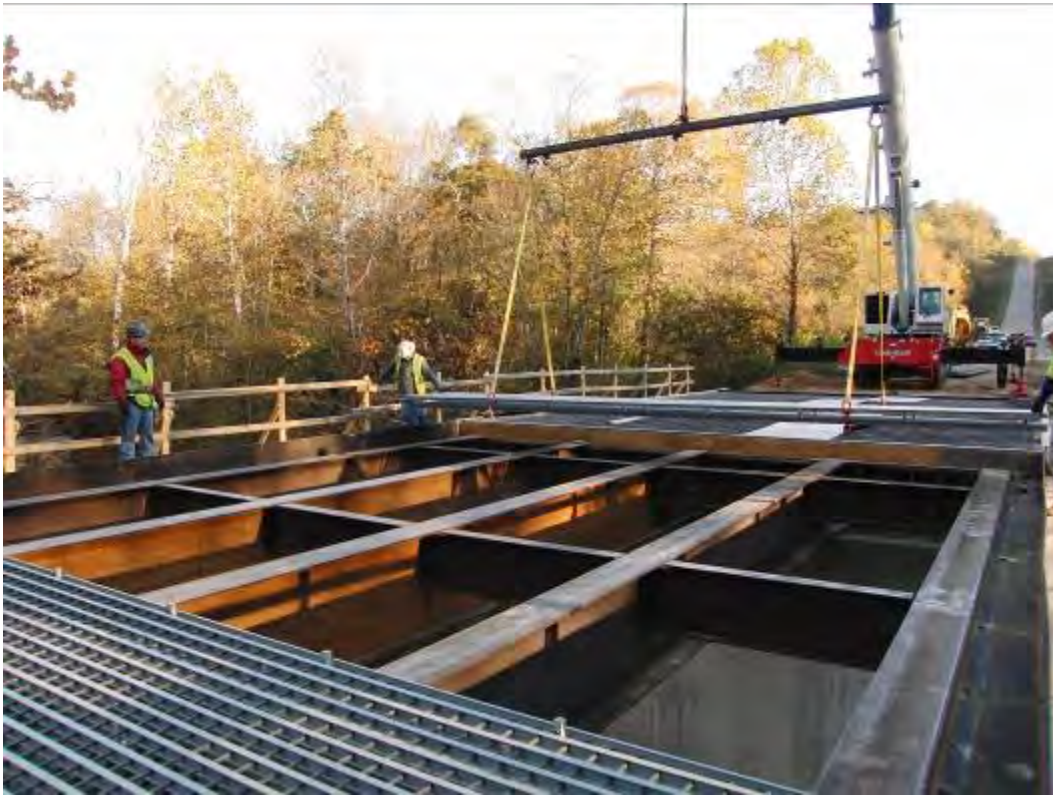
Installation of the FRP reinforcement sections, not including the concrete pour, was completed in 4 hours by a three-person crew and a crane operator. The sections used in this project were light enough to be manipulated into place by hand (Figure 7), once they were positioned by the crane. The labor savings attributable to the section's light weight is a major advantage during installation of this technology. The construction contractor estimated that deck construction time was reduced by at least 80% on this span. More rapid installation of the panels allowed much faster placement of the concrete, saving further time and labor. The Bridge No. 4 contractors estimated that the reduced manpower requirement and speed of installation led to a 75% reduction in total labor costs for this deck, compared to the adjacent steel reinforced concrete deck documented in the companion demonstration report, ERDC/CERL TR-16-22 (Sweeney et al. 2016). The finished bridge deck is shown in Figure 12.

Figure 4. Crane lift of FRP reinforcement panels.

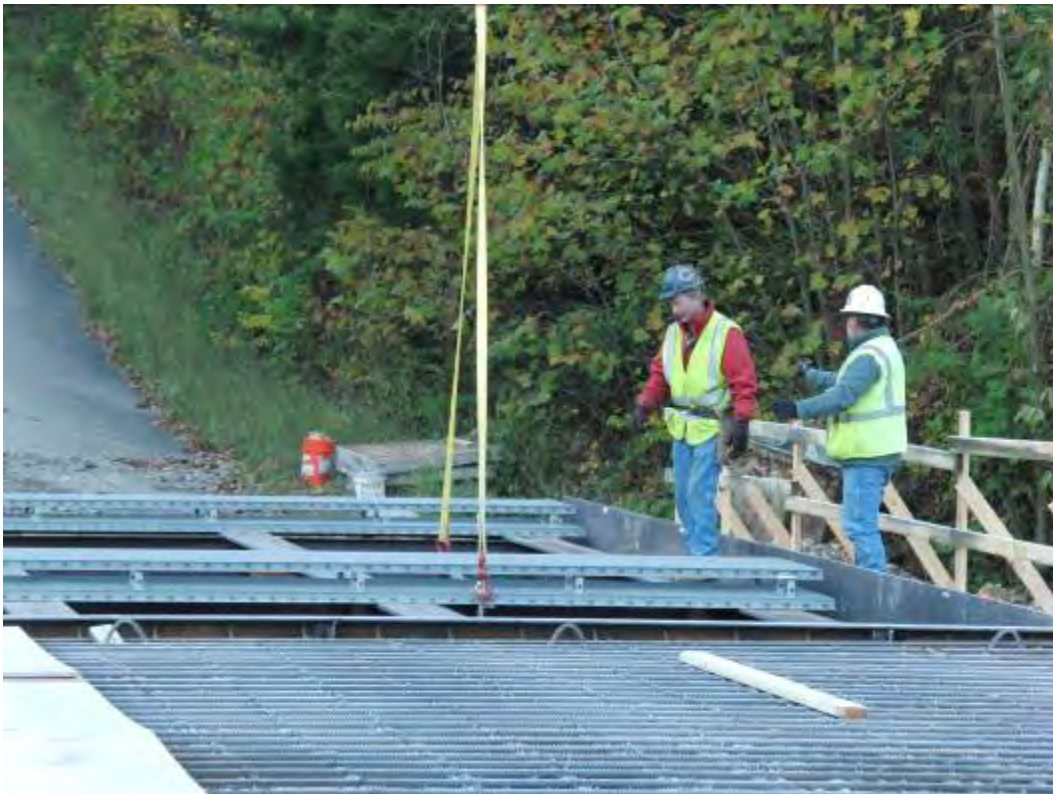
Figure 5. Placing FRP reinforcement panels by crane.

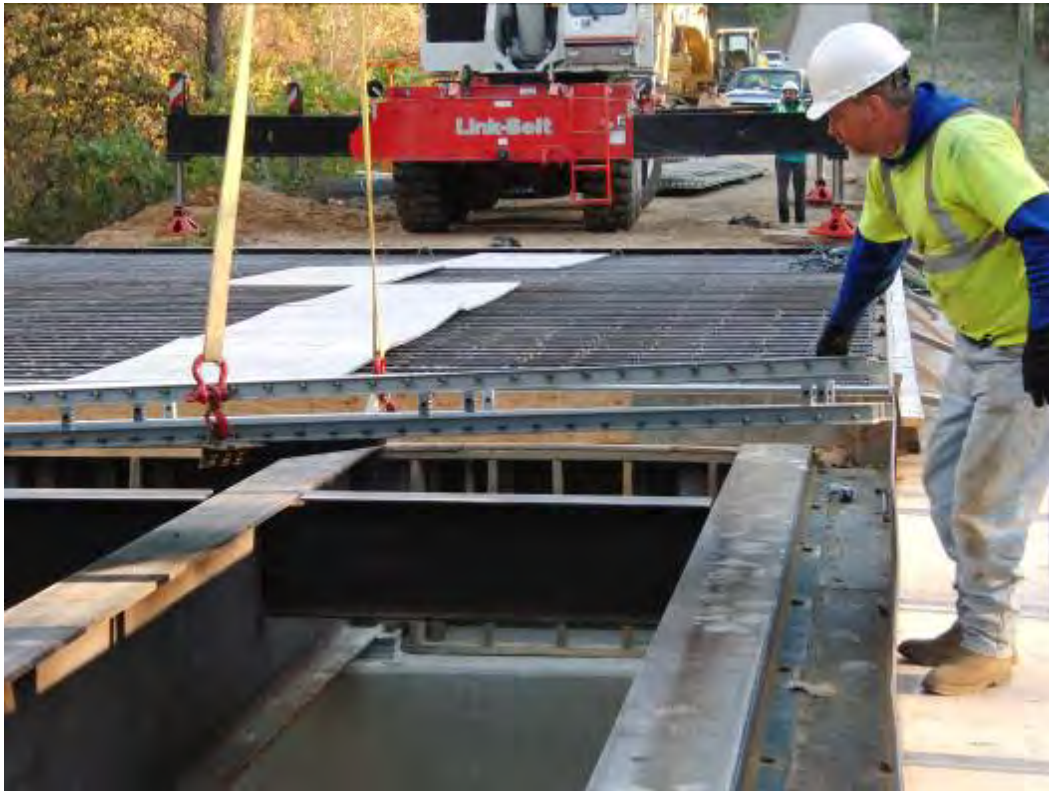
Figure 6. Guiding the FRP reinforcement panel installation.

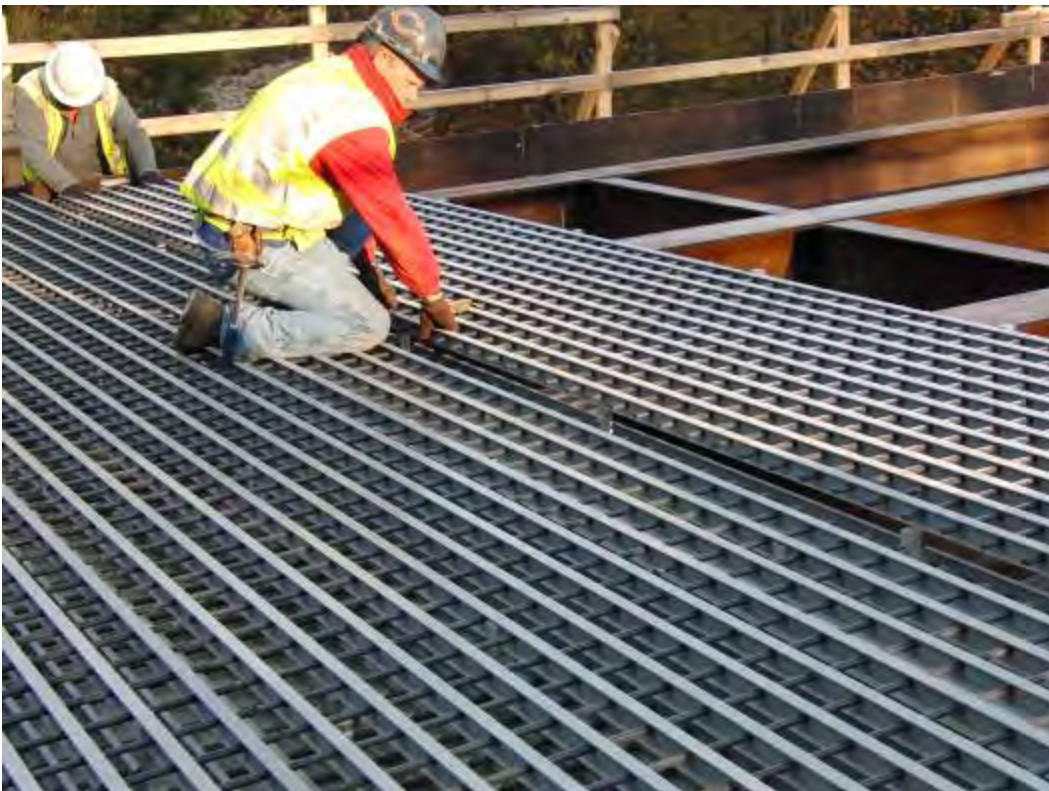
Figure 7. Manipulating the FRP reinforcement panels by hand.

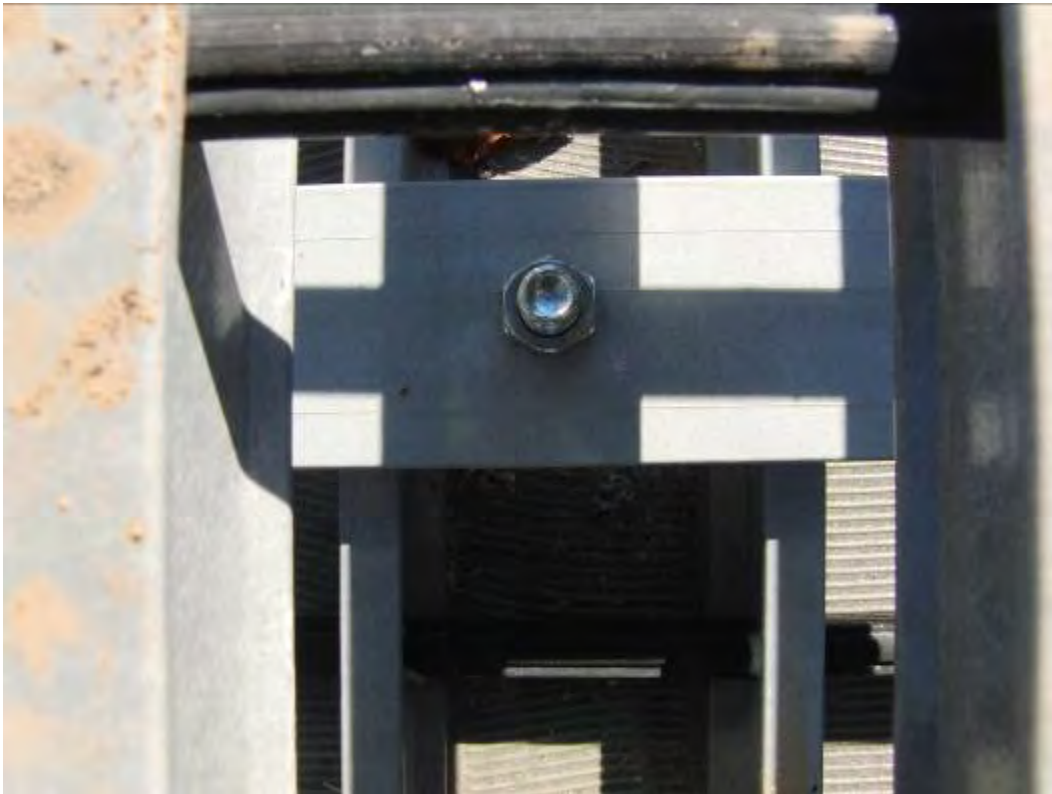
Figure 8. Fastening the bottom layer of FRP I-bars to the steel beam using FRP blocks and stainless steel bolts, shown from above.

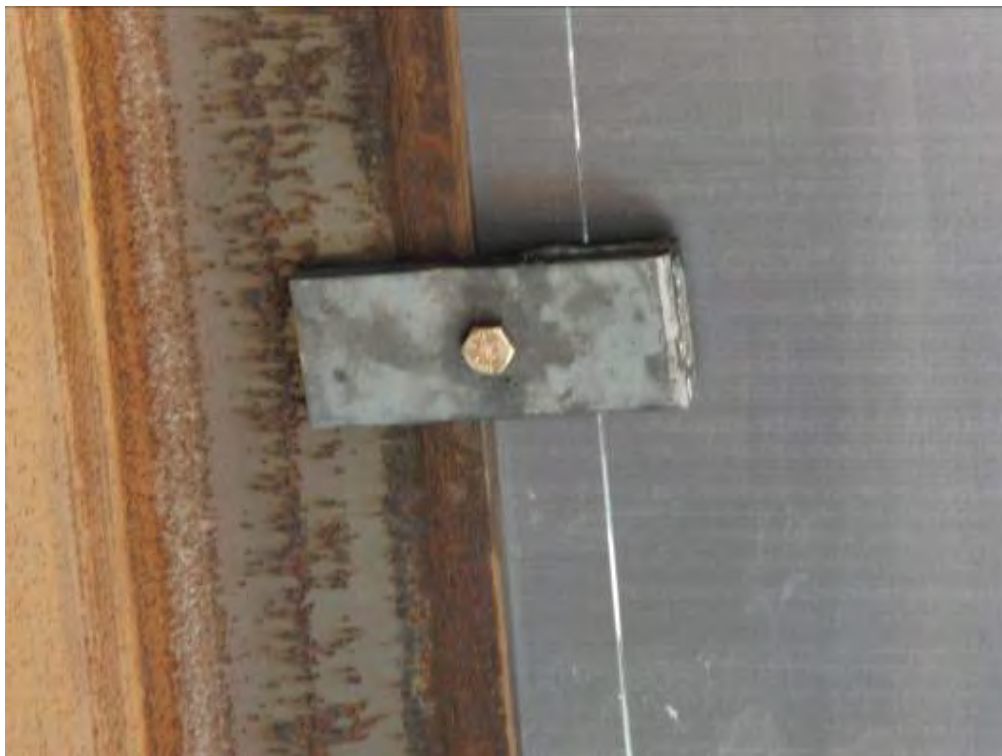
Figure 9. Fastening the FRP reinforcement panels to the top flange of the steel beam, using FRP blocks and stainless steel bolts (shown from below).

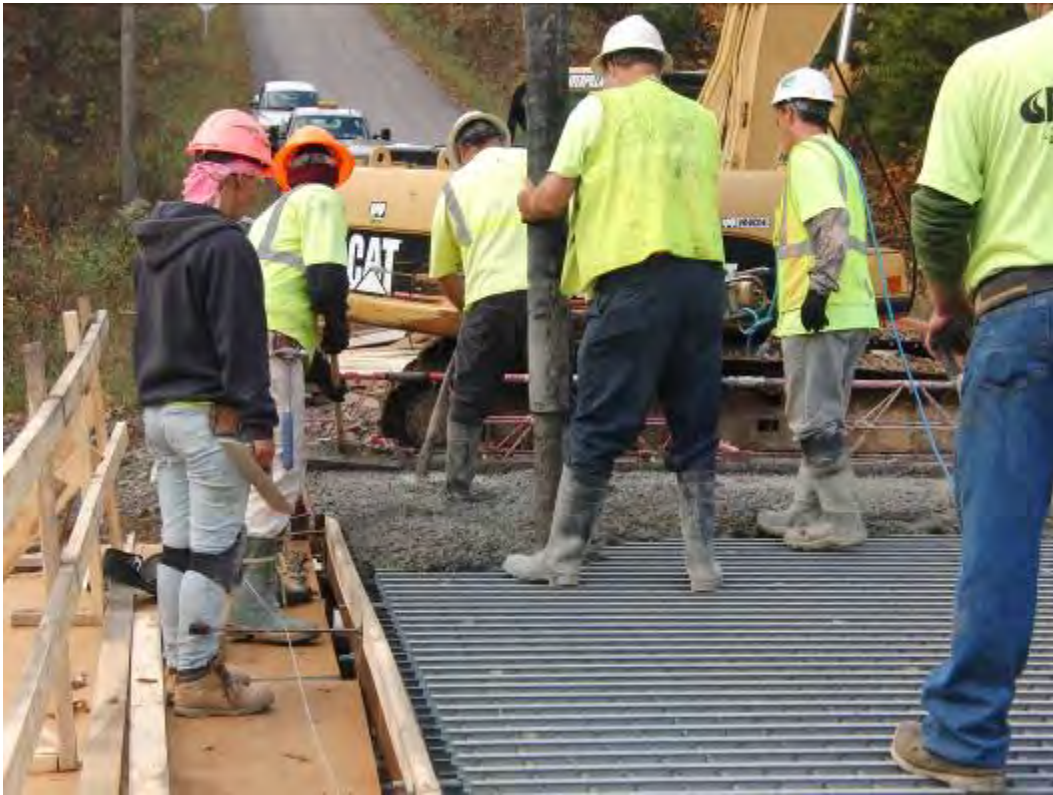
Figure 10. Concrete pouring and vibrating.

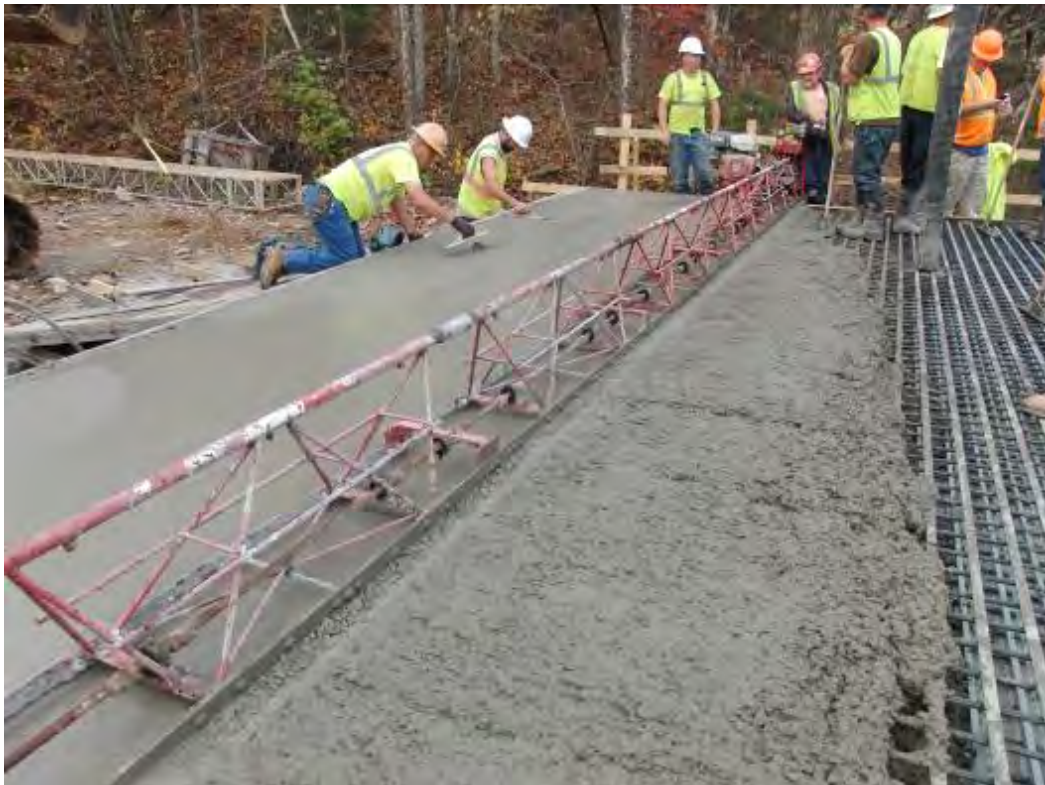
Figure 11. Spreading of concrete over the FRP reinforcement.

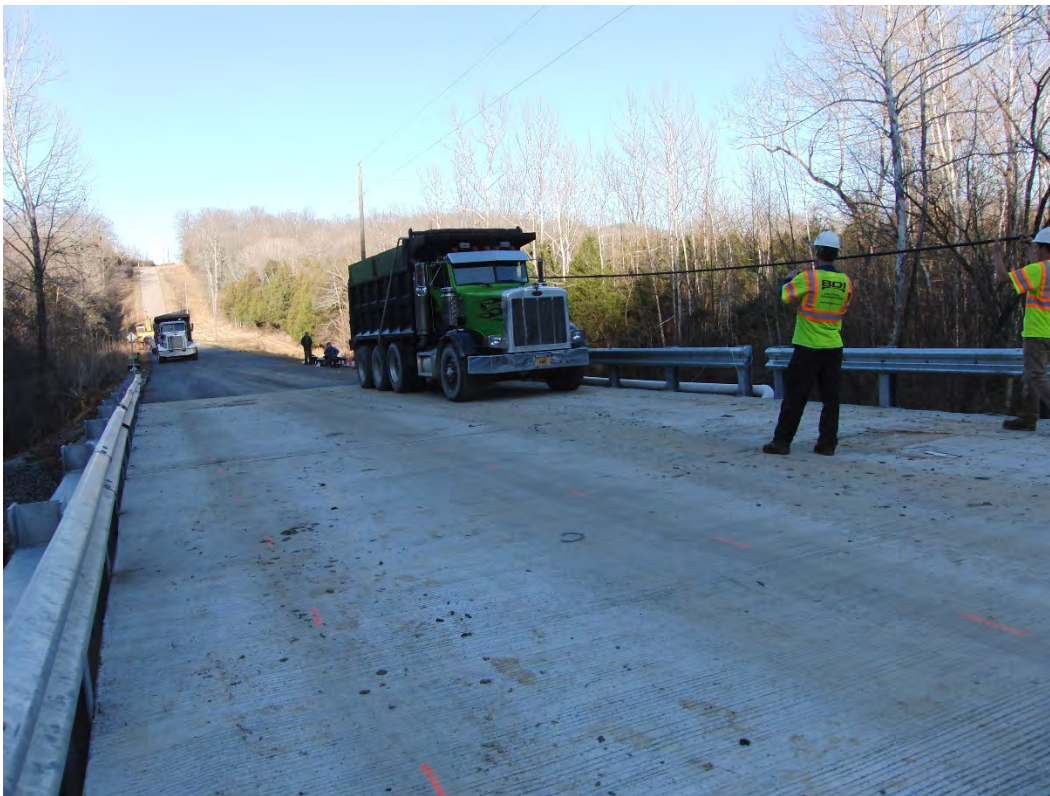
Figure 12. Finished bridge deck with the Gridform section in the foreground, and the conventional deck in the background (break is at the guardrail gap).

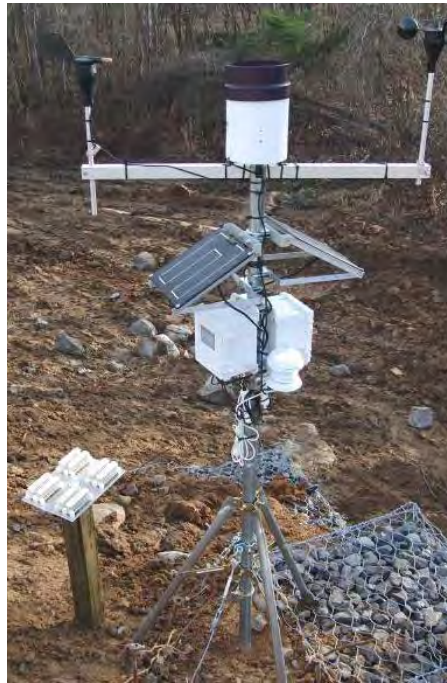
A weather station was installed to measure and record environmental characteristics throughout the exposure period as shown in Figure B1. The station measured temperature, relative humidity, wind speed and direction, and rainfall. The weather station was powered by a solar panel and a rechargeable battery. A data logger was used to store the measurements which were recorded every 12 hours by the rain gage and every 15 minutes for the remaining sensors. Data was downloaded manually during each quarterly inspection through the use of a laptop computer. The data logger has a storage capacity to continue storing data at 15-minute intervals for approximately 2.5 years. Upon reaching full capacity, the data logger will truncate the oldest data point to create room for new, incoming data.

Figure B1. Weather station.

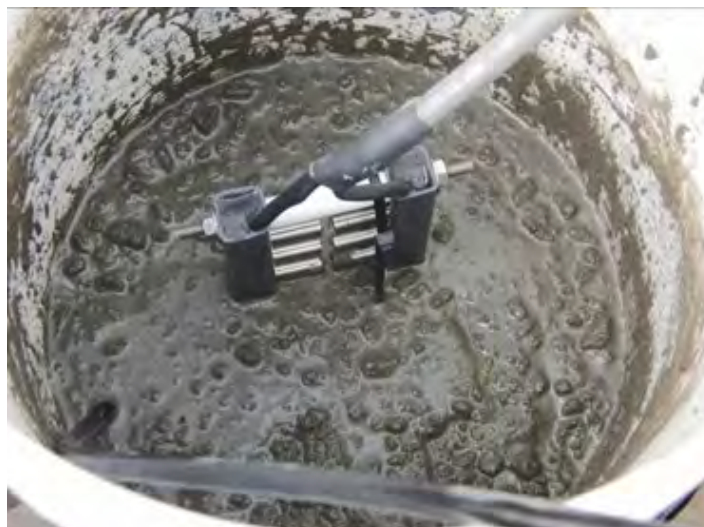
A concrete coupon was formed in a 5-gallon bucket to provide a method to simulate chloride penetration. The bucket was filled approximately half-way with a concrete mix including one cup of sodium chloride. A corrosion ladder was situated in the form such that the chloride enriched concrete covered the first two set of electrodes of the chloride sensor. A corrater was also submerged in the concrete. The concrete was provided 24 hours to cure before filling the rest of the form with standard concrete. Figure B2 shows the chloride-enriched concrete covering the corrater and half of the chloride ladder sensor. Figure B3 shows the cured concrete coupon. Measurements were collected during the quarterly inspections.

Figure B2. Coupon preparation.

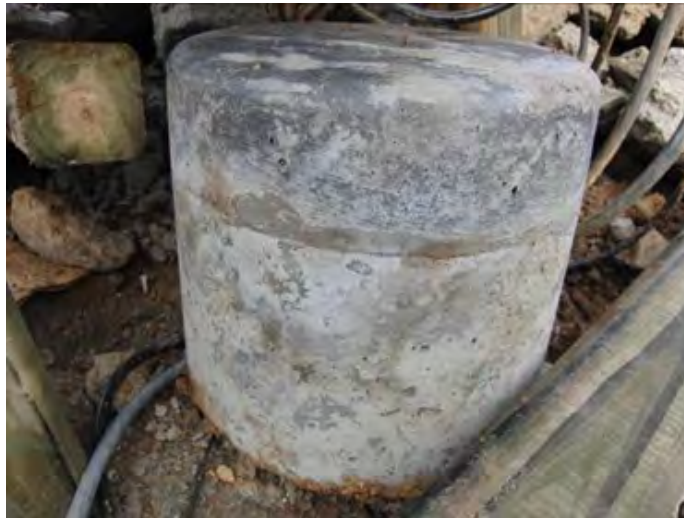
Figure B3. Finished coupon.

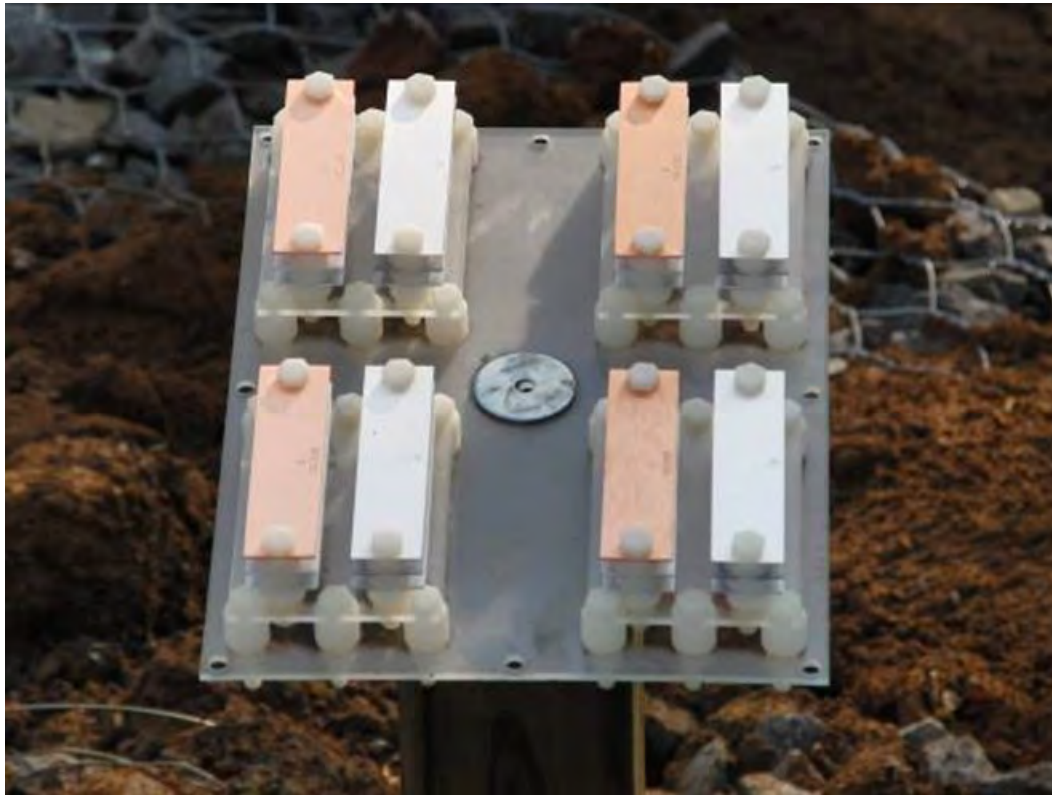
An atmospheric coupon rack to determine the relative corrosivity of the site was installed facing 90 degrees from vertical at the bridge site (Figure B4). The corrosion coupons included silver, copper, 1010 steel, and three aluminum alloys (2024 T3, 6061 T6, and 7075 T6). The coupons measured 1 in. wide by 4 in. long by 1/16 in. thick. These coupons were collected after 6 months and 12 months of exposure. The mass of each coupon was recorded before being exposed to the test environment. The silver coupon was tested for chlorides in accordance with ASTM B825. The remaining coupons were analyzed for mass loss in accordance with ASTM G1-03.

Figure B4. Atmospheric corrosion test rack.

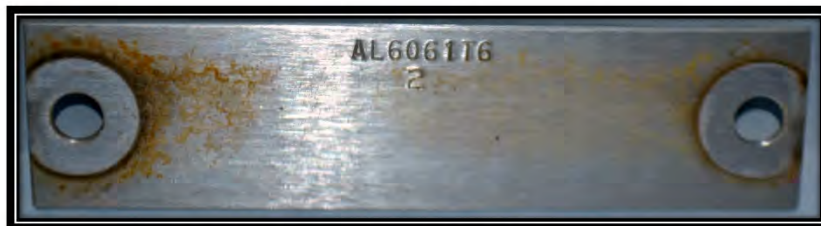
**Figure 1:** AL6061 T6 Sample prior to Corrosion Removal

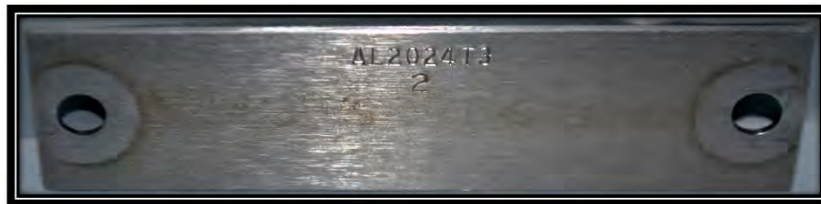
**Figure 3:** AL2024 T3 Sample prior to Corrosion Removal

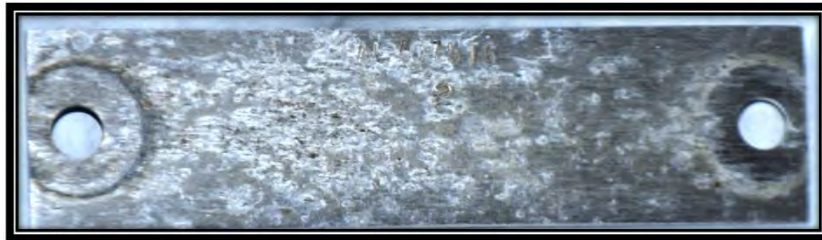
**Figure 5:** AL7075 T6 Sample prior to Corrosion Removal

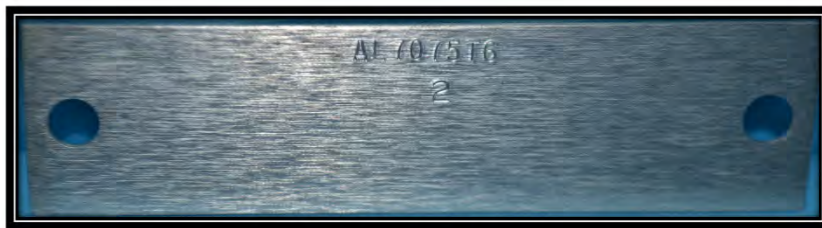
**Figure 6:** AL7075 T6 after Corrosion Removal

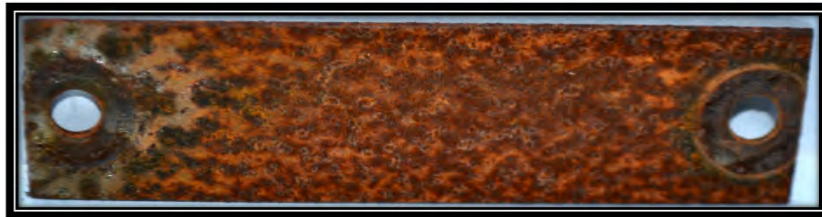
**Figure 7:** C1010 Sample prior to Corrosion Removal

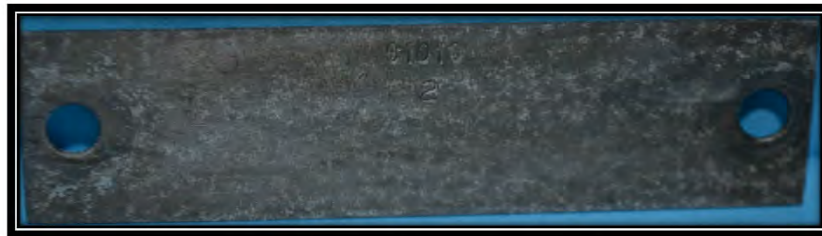
**Figure 8:** C1010 after Corrosion Removal

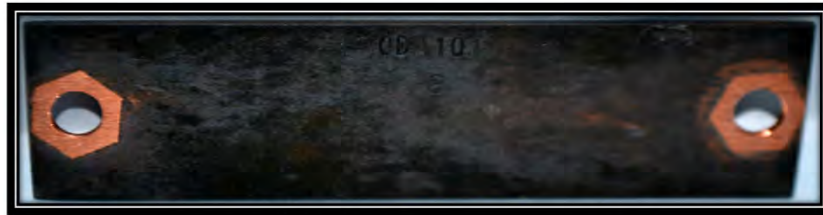
**Figure 9:** CDA101 Sample prior to Corrosion Removal

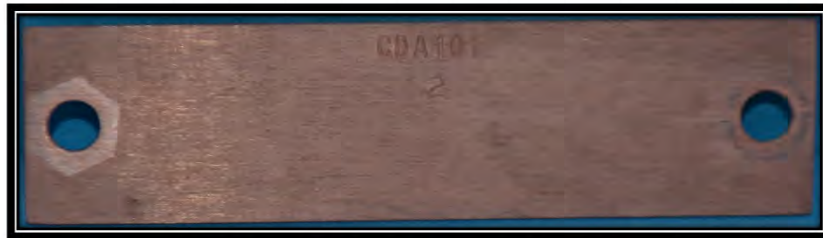
**Figure 10:** CDA101 after Corrosion Removal
