PULTRUDED STAIRS ELIMINATE CORROSION CYCLE FOR OCEANFRONT LODGING

TECHNICAL DATA

Product:	Oceanfront Lodge Entry Stair System
Process:	Pultrusion
Materials & Sizes:	EXTREN® Series 525 Structural Shapes
For:	SRH Corporation
User:	Seaside Inn

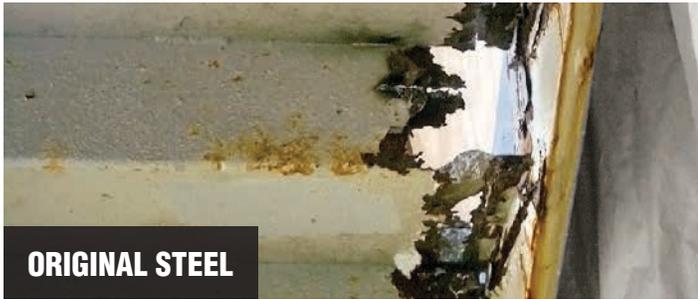
ORIGINAL STEEL

The lodge's main lobby area is located on the first floor, which is 12 ft. above ground level. For years, the access stairs to the lobby were concrete and metal, which continually rusted. Eventually, the stairs deteriorated beyond repair. The management company reported that it spent over \$2,500 annually to have the stairs sand-blasted, rust treated, and repainted. The overall annual process would create inaccessibility of almost two weeks with no significant improvement to aesthetics. Rust began to quickly reappear within 60 days of treatment.

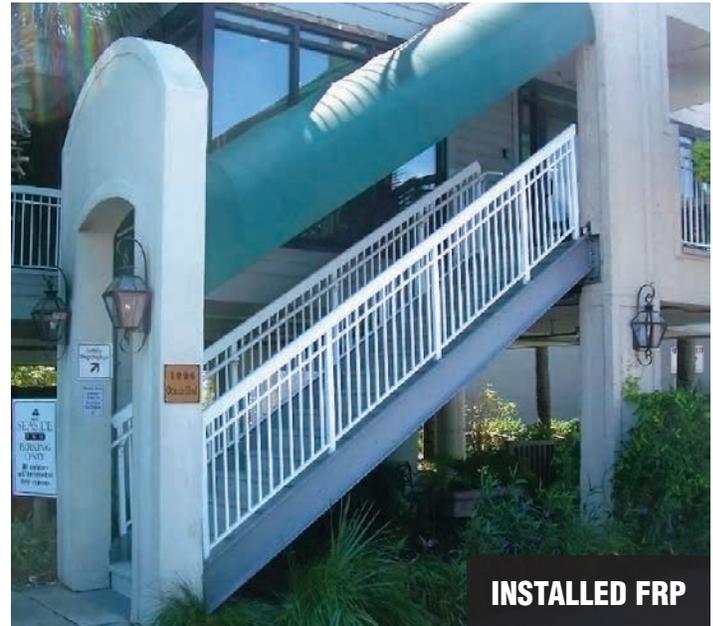
INSTALLED FRP

After 11 years of continuous use, engineers and guests still have to be persuaded that the steps are pultruded fiberglass. Based on the success of this project, the HOA voted to replace the property's 8' wide elevator access stairs with EXTREN® as well. ●
