CASE STUDY

GRATING PROVIDES CONTAINMENT SYSTEM TRENCH SUPPORT

TRANSFORMER CONTAINMENT TRENCH GRATING 0867

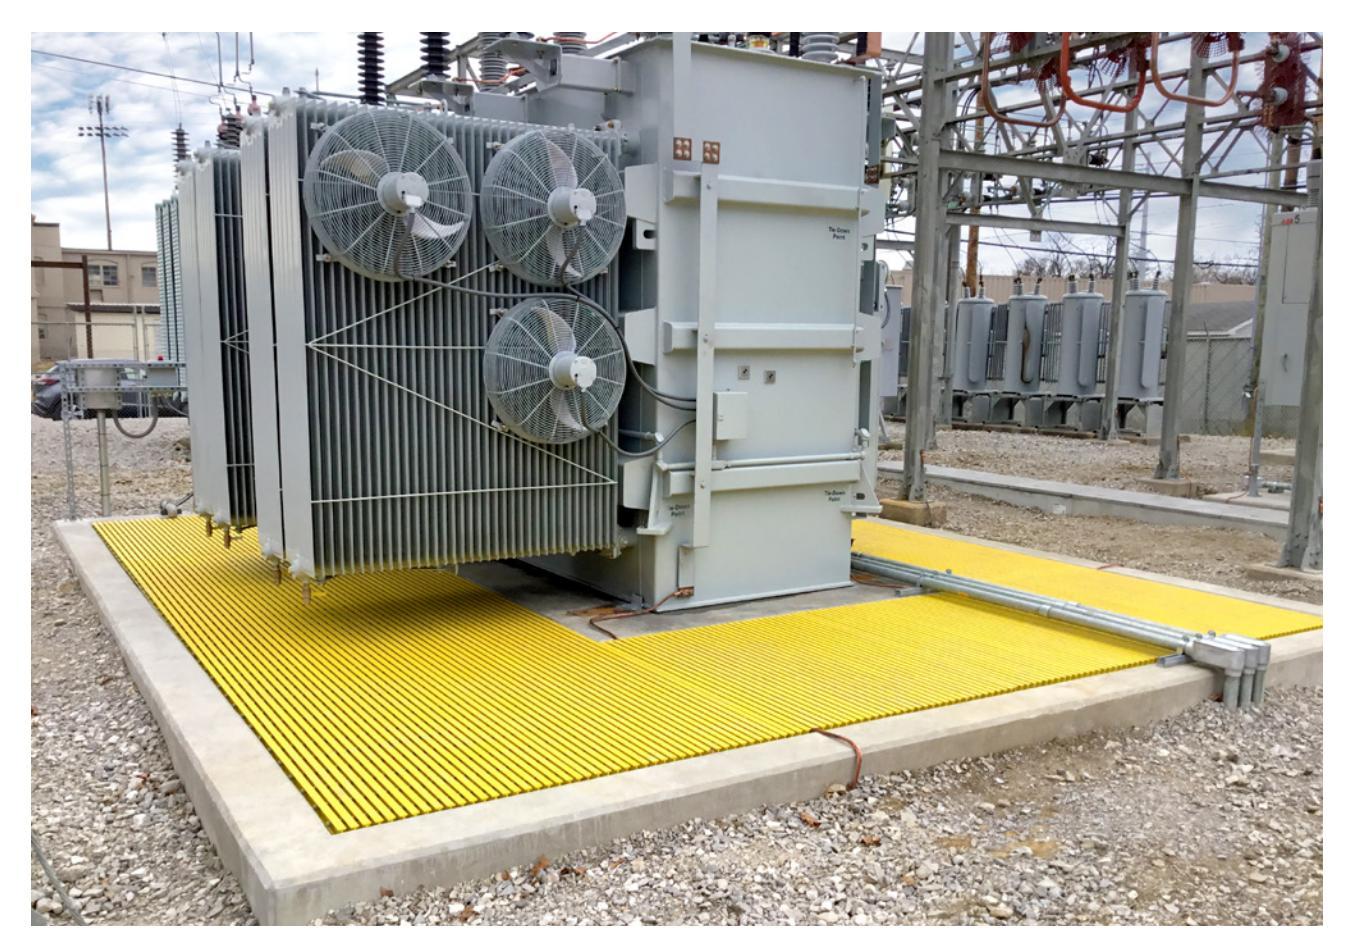
Although there are multiple approaches towards spill containment and management, a major utility provider in Indiana built concrete trenches around their individual substation transformers to mitigate any transformer oil leakage in the event of an equipment failure. In addition to using concrete, the electric utility placed DURAGRID[®] T-3300 grating panels over the trench to provide a safe and durable accessway for transformer maintenance.

In the event of a spill, the 1/2" of open space between grating bars allows residual oil to quickly drain into the containment area. The discharged oil could also be removed by lifting sections of the lightweight panels (3.9 lbs. per sq ft) without the introduction of heavy-duty lifting machinery into the fenced-in complex.

The nonconductive nature of the pultruded grating and its bright yellow color chosen for this application also serve as added safety features around the electrical substation. This is the third installation of DURAGRID[®] pultruded grating with this energy provider. The end user has been pleased with the service and overall performance of the material and will continue to install DURAGRID[®] pultruded grating on both new and retrofits of old substation containment systems.

Product:	Transformer Containment Trench Grating
Process:	Pultrusion, Fabrication
Materials & Sizes:	DURAGRID [®] 2" T-3300 Pultruded Grating
For & User:	A Major Utility Provider in Indiana
