## APPLICATION PROFILE

### FIBERGLASS BEAMS BRING RELIABLE POWER TO THE PEOPLE

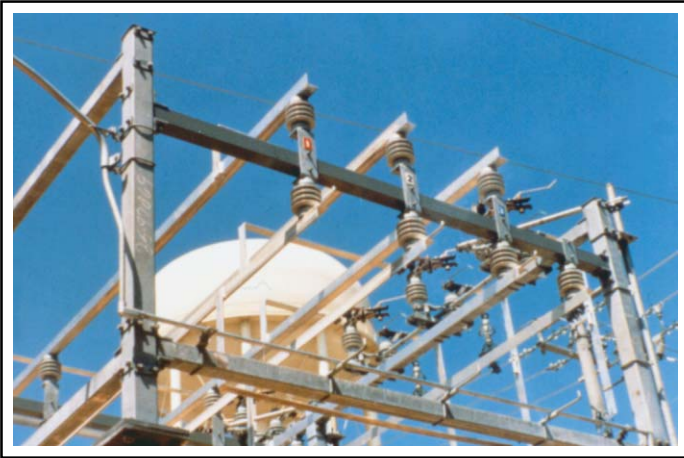
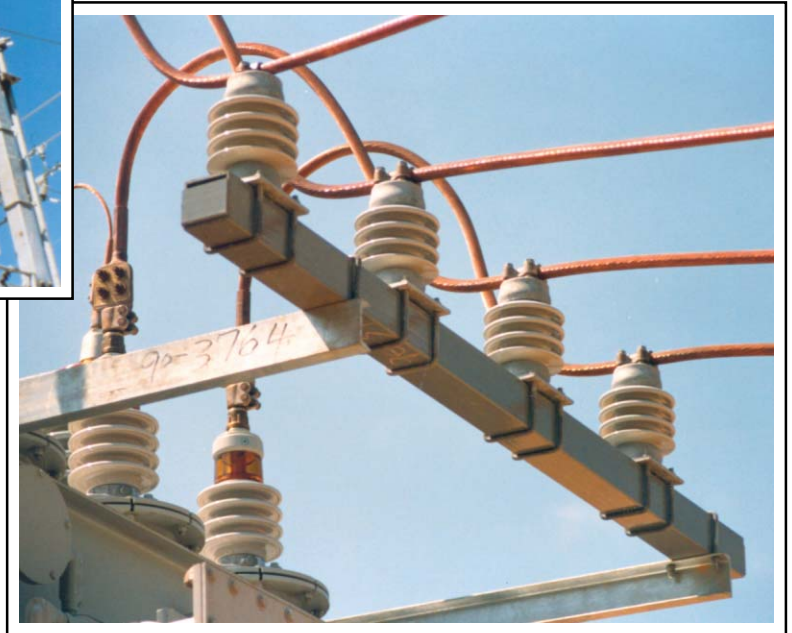
“We are using fiberglass feeder beams and bus support beams instead of galvanized steel on transformer units in areas which have high squirrel populations,” said Richard Adams. “The fiberglass beams, though not grounded, act as an insulator and so far the idea seems to be working. As far as we know there have not been any power outages caused by squirrels in these areas.”

The program has been underway for about a year now and if it continues to succeed, the steel cross arms on transformers across the state, in troubled areas, will be replaced with EXTREN® Series 525 fiberglass square tube. The fiberglass cross arms are supplied with a polyurethane coating to enhance their weatherability. As shown in the photo, 4" lengths of EXTREN® square tube are inserted into the ends of the fiberglass cross arms to prevent small animals and birds from building nests inside the hollow fiberglass cross arms.

Product:	Fiberglass Feeder Beams and Bus Support Beams
Process:	Pultrusion
Materials:	EXTREN® Series 525 fiberglass reinforced polyester, fire retardant, polyurethane coated
Sizes:	4" x 1/4" x 4' Square tube
For:	J. M. Tull Metals Co.
User:	Alabama Power Company
