APPLICATION PROFILE

HORSE SHOW RING MAINTENANCE FREE AND LOOKING GOOD

FIBERGLASS HORSE SHOW RING

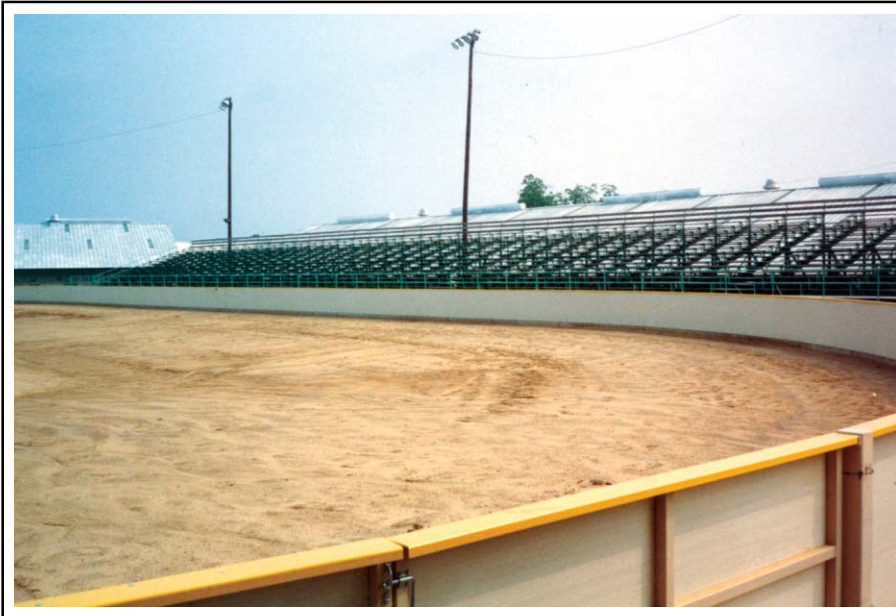
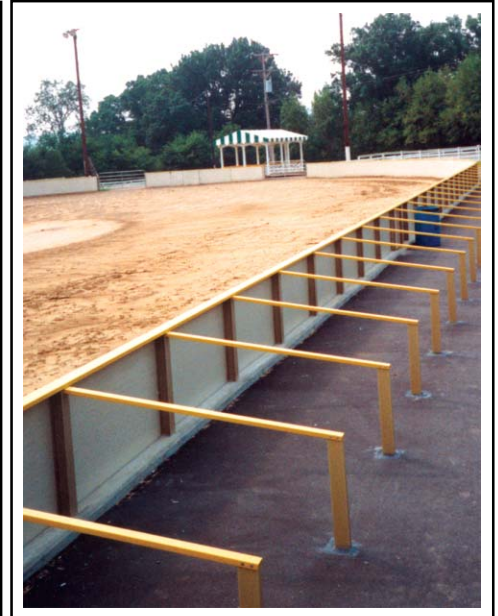
EXTREN® Series 625 structural shapes, special “white” 3/16" thick fiberglass plate and yellow channel sections were fabricated into the fiberglass oval fence system and gates (744 lineal feet around the track) shown here.

Product:	Fiberglass Horse Show Ring
Process:	Pultrusion
Materials:	EXTREN® Series 625 fiberglass reinforced vinyl ester, fire retardant
Sizes:	EXTREN® structural shapes: Main Fence Posts - 4" x 4" x 1/4" Wide flange beam Box Seat Posts - 4" x 2" x 1/4" x 3/8" Rectangular tube Main Cap Rail - 5" x 1-3/8" x 1/4" Channel Box Seat Cap Rail - 2-5/8" x 1-1/4" x 1/4" Channel Gate Perimeter Rails - 1 3/4" x 1/4" Square tube Fence Facing - 3/16" Plate, 42" wide x 18' long
For:	Tenn-Plast Engineering
User:	Nashville Fairgrounds
