APPLICATION PROFILE

FRP HANDRAILS AND STAIRS PROVIDE SAFE ACCESS

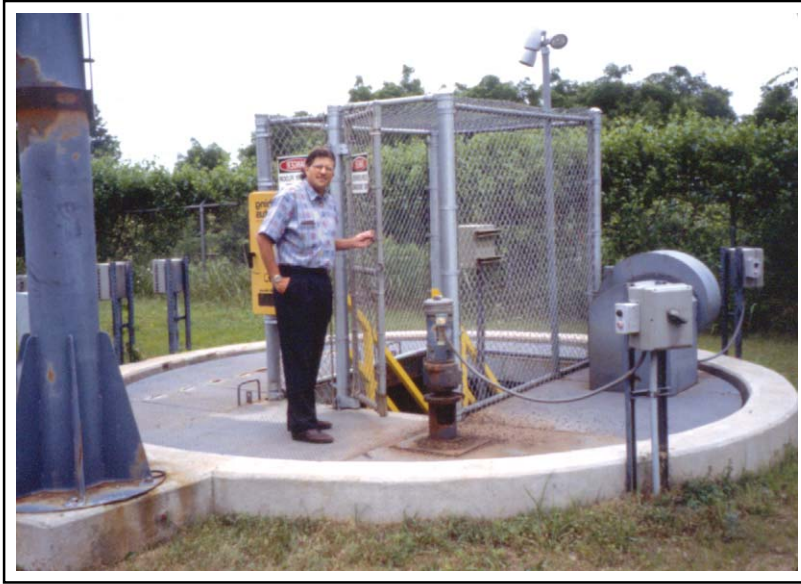
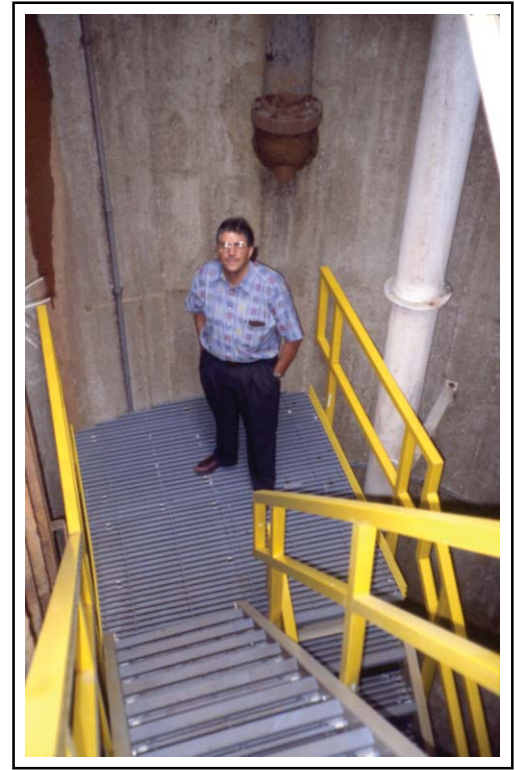
The Choctaw Waste Treatment Plant in Choctaw, Oklahoma, has a new fiberglass stairway to replace a badly corroded steel spiral stairway. The stairway provides access to the bottom of the headworks where samples must be taken from the raw sewage that enters the waste treatment plant.

The steel structure and handrail were severely pitted and corroded from the sewer gas within the headworks, which is highly corrosive and very damp. In addition, the stairs were very narrow and steep. Bernie Nauheimer at the Choctaw plant and Gene Sayers of Design Engineers, Inc. of Oklahoma City, Oklahoma, worked with Strongwell to develop a design for the access stairway to solve the problem. The new design utilized landings and wider stair treads and was made of vinyl ester DURADEK® I-6000 and EXTREN® Series 625 structurals to provide superior corrosion resistance. The DURADEK® non-skid surface also provided better footing for worker safety.

Product:	Fiberglass Access Stairs
Process:	Pultrusion, Fiberglass Fabrication
Material:	EXTREN® Series 625 fiberglass reinforced vinyl ester structural shapes, fire retardant DURADEK® I-6000 1" fiberglass reinforced vinyl ester grating, fire retardant, gray SAFRAIL™ fiberglass reinforced vinyl ester handrail, fire retardant
For:	Design Engineers, Inc.
User:	Choctaw Waste Treatment Plant
