# STRONGWELL

## APPLICATION PROFILE

### FRP MATERIALS GUARD A CALIFORNIA PIER FROM CORROSION

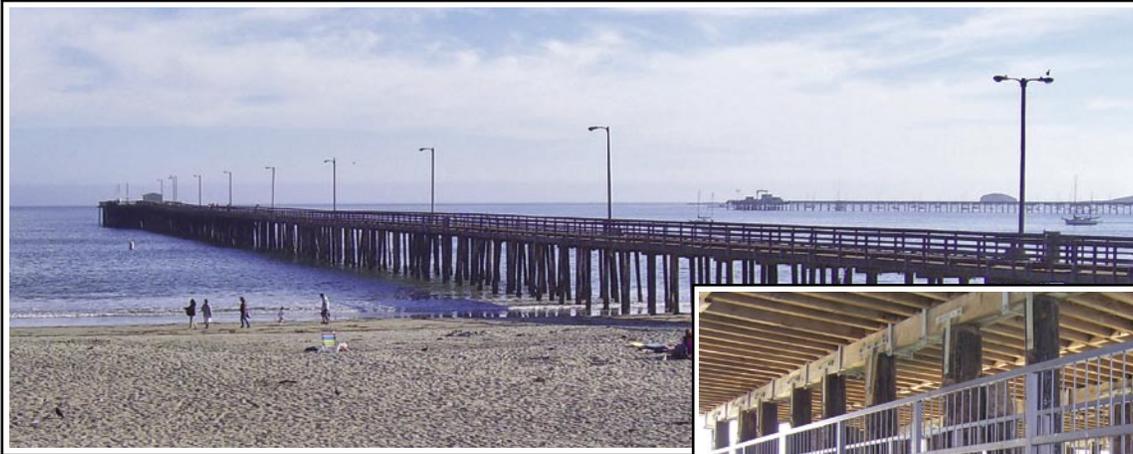
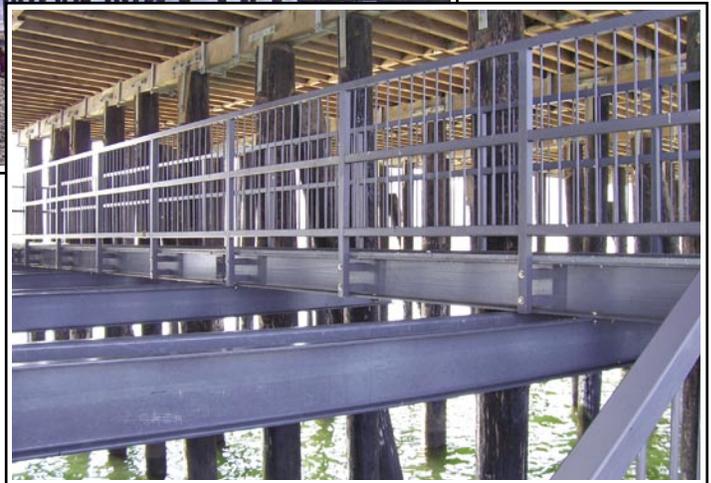
The Avila Beach Pier in California has been reconstructed using Strongwell's pultruded fiberglass structural materials. The 1,685-foot public pier was in need of a support system and large stairwell at the end, allowing public access for landing boats and unloading guests.

The pier is constantly exposed to a harsh saltwater environment and is always under attack from the corrosive elements. In fact, parts of the stairwell are entirely submerged in saltwater at all times. Strongwell's FRP support system for the base of the pier consisted of EXTREN® I-beams and channels, replacing the existing galvanized platform which was failing in the salt-water environment. DURADEK® pultruded grating and stair treads and SAFRAIL™ handrail was also installed creating the new walkway. The fiberglass reinforced materials were chosen over traditional building materials because of the superior corrosion resistance and strength that it offers.

Product:	Support system and stairwell for pier
Process:	Pultrusion
Materials:	EXTREN® Series 525 fiberglass reinforced polyester, UV coating DURADEK® 1.5" I-6000 fiberglass reinforced vinyl ester grating DURADEK® stair treads SAFRAIL™ fiberglass reinforced polyester handrail and stair treads
Sizes:	10" Wide flange I-beams 10" Channels
For:	Pat Dalton Construction
User:	Avila Beach, California
