## FIBERGLASS TURRETS STILL CROWN THE ORLANDO SKYLINE 30 YEARS LATER

Within the urban skyline landscape of Orlando, Florida, four 35' high x 35' square fiberglass turrets flank one another atop the SunTrust Bank Building, providing Orlando's tallest building with an architecturally inspired spire crown.

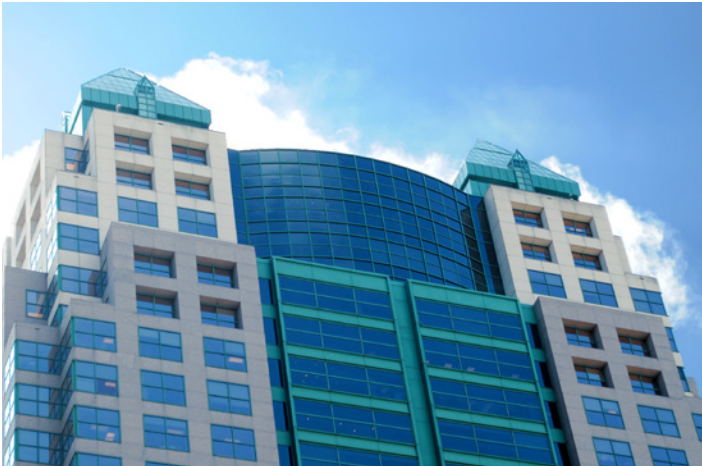
Each turret has four windows with the frames fabricated from EXTREN® Series 525. Three sides have 27' high x 5' wide windows and one side has a 10' high x 5' wide window. Each fiberglass superstructure is covered in custom molded fiberglass panels.

Originally conceived over 30 years ago as steel and aluminum decorations, the fiberglass turrets of EXTREN® structural shapes and FIBREBOLT® fiberglass studs and nuts housed 20' high antennae for first responders' communication. As an industry leader, Strongwell's fiberglass structural products comprehensively gained L.A.R.R. approval. This certification allowed the developer to alter the metallic design to composites due to composites transparency to radio signals.

All-fiberglass structural members were prefabricated and shipped to the site. Structures were almost completely assembled on the ground and lifted to the rooftop via crane. Workers were then able to bolt the fiberglass base plates to steel base plates on the roof.
