FRP IS UDDERLY AMAZING FOR FARMS

Product:	Trench Cover Grating
Process:	Pultrusion, Fabrication
Materials & Sizes:	DURAGRID® HD-6000 1-1/2" Pultruded Grating
For:	The Westfall Company
User:	A dairy barn operator

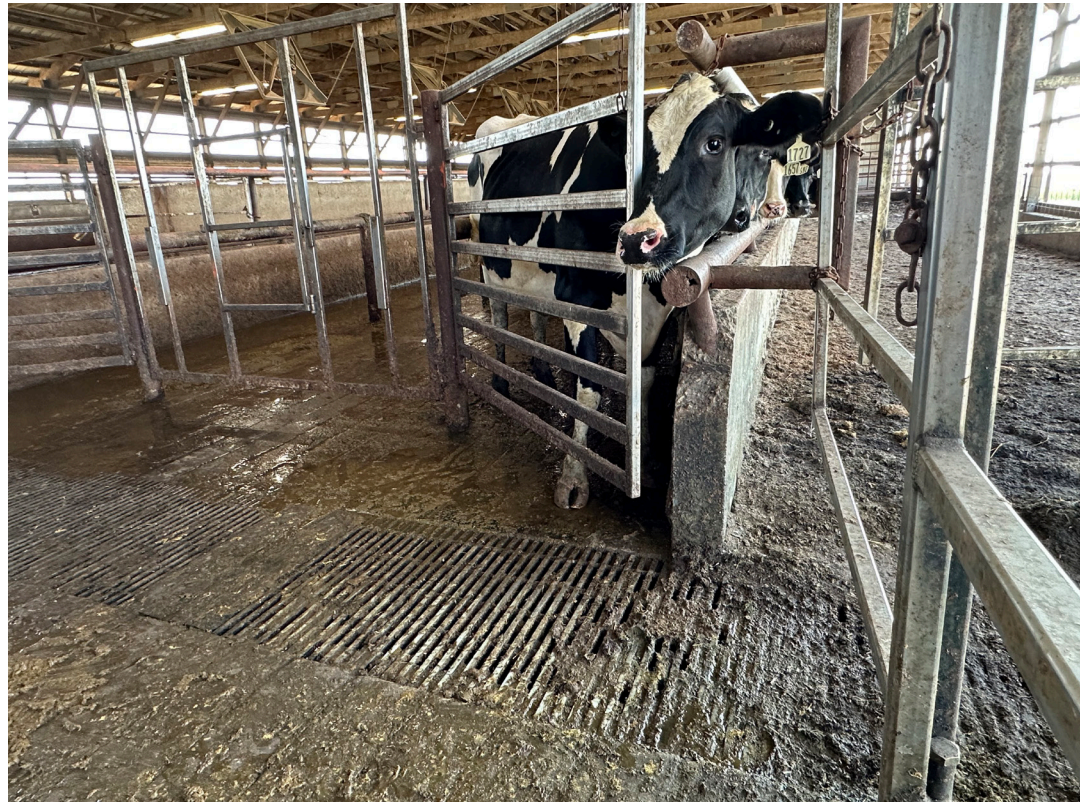
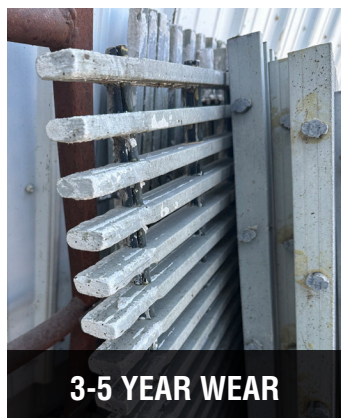
The farm transitioned into 1-1/2" DURAGRID® HD-6000 grating to better accommodate nonvehicular traffic over the flooring surfaces in the indoor barn area. To sanitize these congregation areas, the farm utilizes a flush water system that exposes certain areas up to 10,000 gallons of water per minute paired with cleaning agents.

Due to cows having a limited depth perception and sensory comfort, the minimal spacing between grating bars and the embedded pigment that matches the color of the established concrete floor makes for easier hoof transition from one surface material to another.

Since the installation of DURAGRID® HD-6000, the dairy farm has been pleased with the long-term replacement cycles of the FRP grating panels (3-5 years) compared to less than a year with metallics. In addition, when replacement is necessary, the FRP grating panels can be quickly and easily cut and fabricated onsite without the use of special tools and without exposing any part of the pasture to sparks or flames. ●
