FRP AMPS UP SHEET PILING

TECHNICAL DATA

Product:	Substation Flood Wall
Process:	Pultrusion
Materials & Sizes:	CMI UltraComposite® UC-75 - 24" x 14" Interlocking Z Profile
For:	CMI Limited Co.
User:	A major utility provider in North Carolina, USA

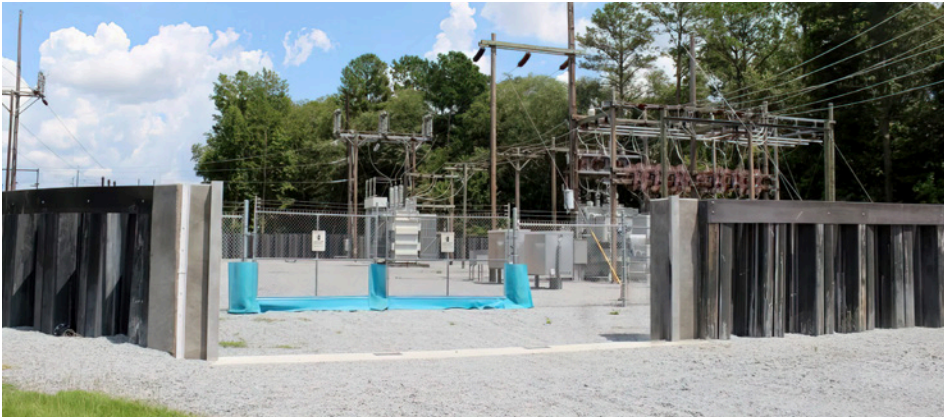
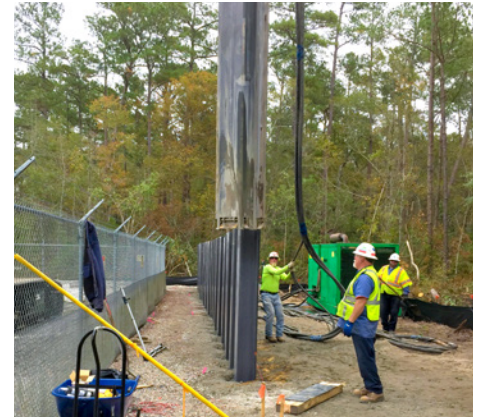
UltraComposite™ 75 Sheet Piling, manufactured by Strongwell, was sourced for several separate substation sites along the coastline of North Carolina. With aggressive project schedules, UC-75 was deemed far superior to steel or concrete in life cycle analyses, non-conductivity, sustainability, and total cost of ownership. At each substation site, sheet piling provided wall lengths ranging from 600 to 1,900 linear feet. Wall heights varied from six to eight feet above grade with tight spacing requirements around each substation.
